## Analysis of Tapial structures for modern use and conservation

P.A. Jaquin & C.E. Augarde

**ABSTRACT:** Tapial is an ancient form of rammed earth wall construction found in many parts of the world. In medieval Spain, Tapial was used in the construction of some large and complex structures, some many-storied. That these buildings remain standing (many remaining in use) is an indication of the durability of this form of construction, and is perhaps related to the climatic conditions found in central Spain. This paper describes an engineering study into an important structure in the Aragon region, significant parts of which are constructed in medieval Tapial, as well as other forms of construction. The aim of the study is both to improve understanding of the nature of this structure and to provide guidance on methods of preservation and new construction.

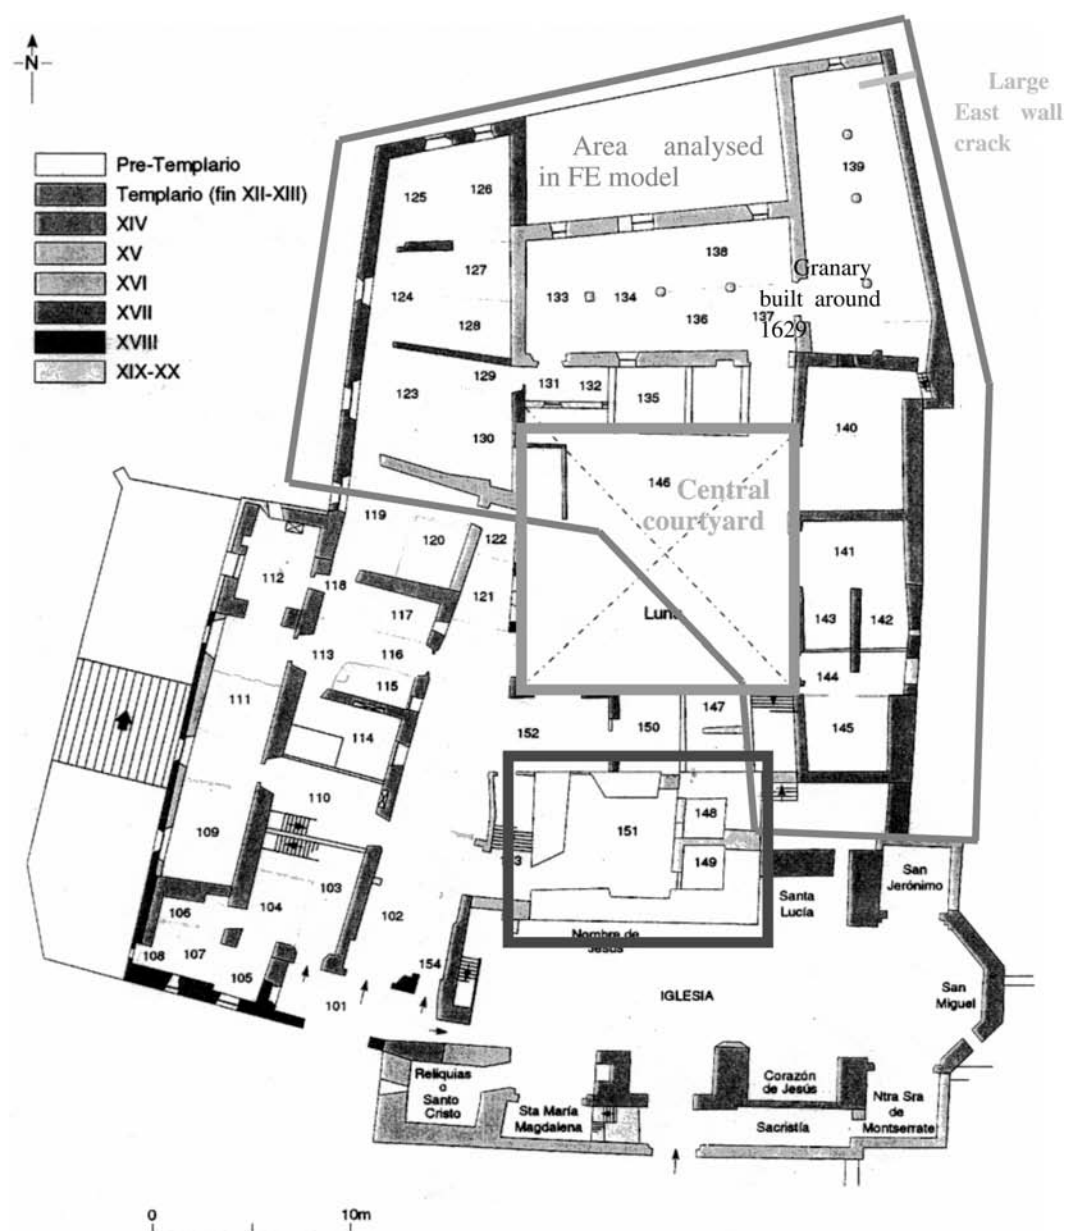
Figure 2. Plan of the Preceptory at Ambel.

the southwest wing. The building remained unoccupied until the early 1990s when a number of structural works were undertaken in order to make parts of the building habitable. At present there is large crack of unknown vintage at the north end of the northeast wall and a smaller, but growing crack in the eaves of the north courtyard wall.

It was decided to model only part of the structure, as the whole building has around 136 rooms on 4 floors. The north wing of the building (Figure 2) was singled out for more detailed study as this area contains the worst structural defects and is at present uninhabited.
